Madame John's Legacy

632 Dumaine Street, New Orleans
A Louisiana State Museum Site

Architectural Guide for Teachers

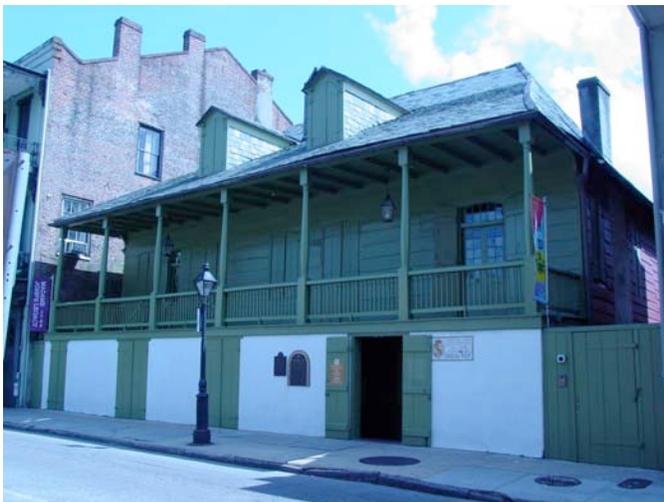
The main house is a one and a half story structure with a raised basement, built on the banquette (sidewalk). The hipped, double-pitched roof has two dormer windows and shelters the wide, second level gallery with its wooden balustrade and slender cypress colonnettes. The walls of the first level are made of brick and covered with stucco. (Brick produced from local soil was soft and porous. It was usually protected from the rain with a layer of stucco.) The second story was constructed of brick-between-posts (briquette-entre-poteaux) and covered with wide clapboards.

Window and door surrounds are simple wood casings with segmental arches. Transoms rest above the French doors. All openings are protected by vertical-board shutters with strap hinges. Notice that the openings are not symmetrical. The exterior surfaces and trim have been painted the original moss green color.

- ② Hipped roof
- ② Wide gallery
- ② Wood balustrade and colonnettes
- ② Exterior stairs
- ② Vertical board shutters with strap hinges
- ② Arched dormer windows
- ② Casement windows and French doors
- ② Wood siding on second floor
- ② Stucco on raised basement

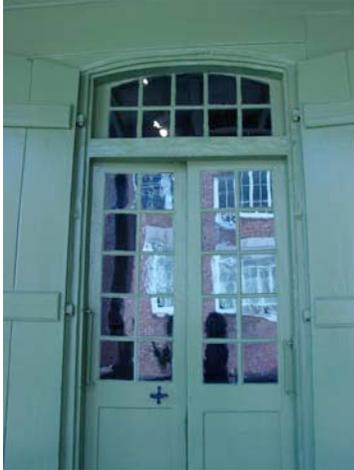
Multi-light French door with segmental arched transom

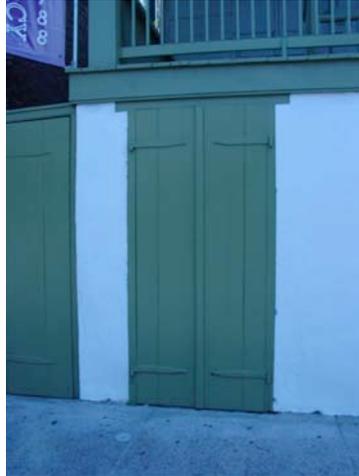
Vertical-board shutter with strap hinge

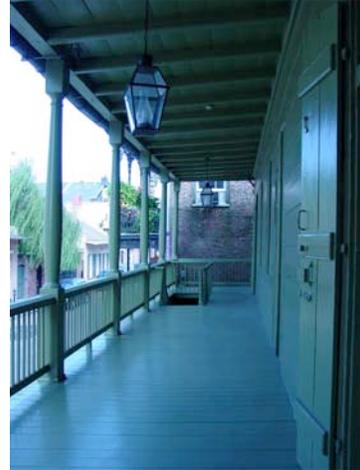
Gallery with colonnettes and balustrade

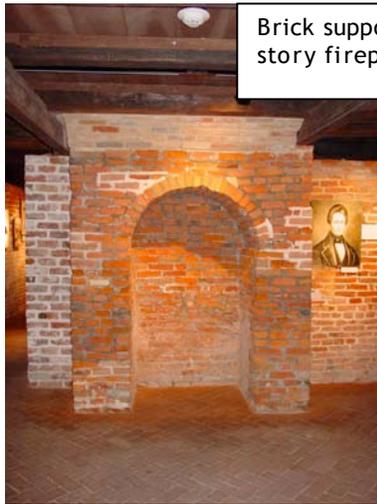
Brick support for second story fireplaces

Structural elements such as the cypress joists of the floor above and the heavy, arched brick supports of the upper fireplaces are seen in the basement. Brick walls built close to the ground would have helped keep this level cool and damp.

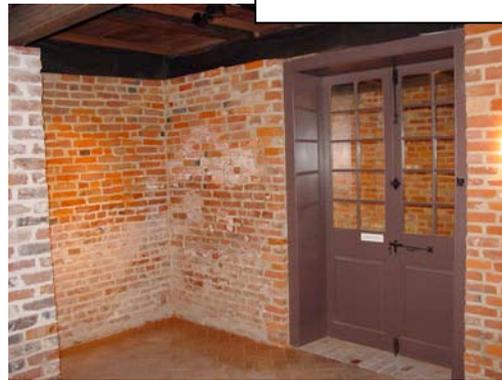
Brick foundation walls in basement

The ground floor is a solid masonry basement, built of brick and covered with stucco or plaster on the exterior street surface. It served as a storage area and workspace as well as a foundation for the living area above. The basement consists of three rooms in addition to two *cabinets* on either side of the *loggia* (covered gallery) in the rear. Stairs are located under the front gallery and in the rear *loggia*.

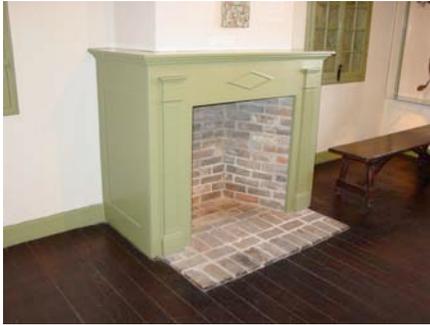
Box mantle

Both floors and ceilings are made of wide cypress boards with the floors left unfinished. Wall surfaces have been plastered and painted in the soft earth colors available in whitewashes of the late eighteenth century. Decorative elements consist of simple paneled doors and large box fireplaces in each room. Wrought iron hardware and "mustache" (s-shaped) hinges provide elegant decorative elements to the doors and windows. The mantelpieces are examples of neoclassical design popular in New Orleans in the early nineteenth century.

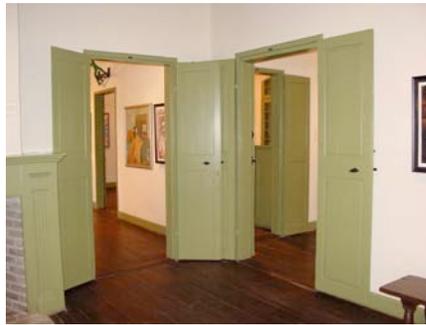
Paneled doors

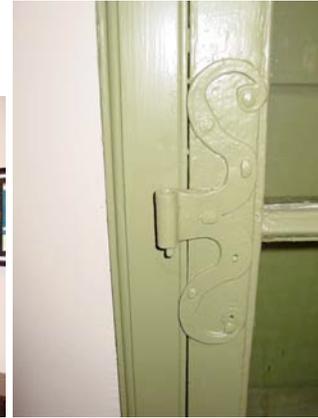
Mustache hinge

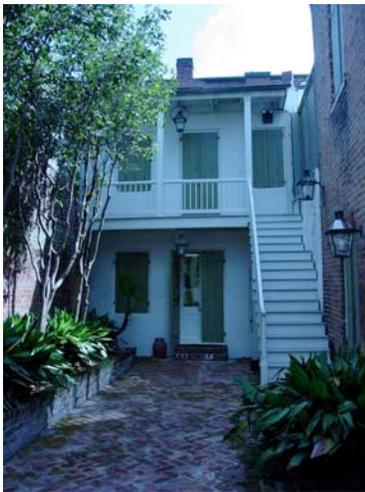
18th Century
Kitchen Building

IV. Courtyard, Kitchen Building & Service Wing (buildings are closed to the public)
Today, the L-shaped courtyard includes the Kitchen Building and Service Wing. Both buildings have steeply pitched roofs and narrow galleries. The two-story Kitchen Building, located in the rear left corner, was probably constructed at the same time as the main house. It has a deep fireplace used for cooking and quarters for the cook located above.

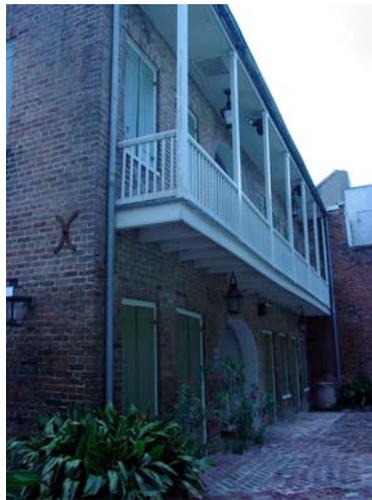
19th Century
Service Wing

The Service Wing is located directly opposite the main house. It was built in 1827 to serve multiple functions. The ground floor housed a new kitchen and a coach-house. The stable for two horses may have been an attached shed in the rear. An arched alcove leads to the second floor, divided into three apartments with one fireplace.

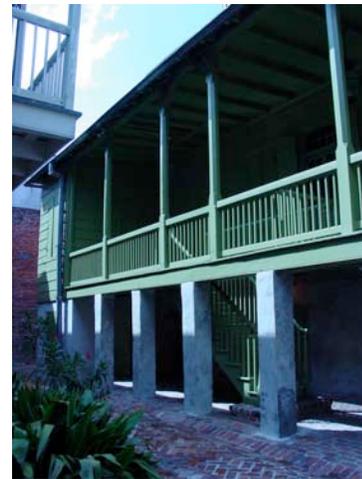
Rear façade of MJL
(cabinets to left)
